RS Composite Utility Pole Inspection and Maintenance Guide

Project: *Pole Inspection Review*

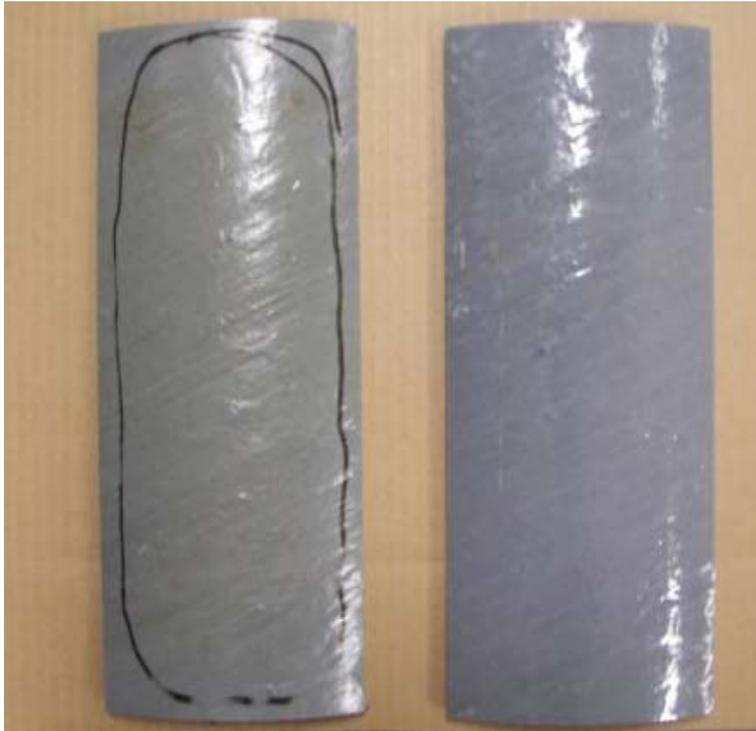
Figure 1: Weathering and UV Exposed Sample vs. Control Sample. (14,010h of QUV exposure on the left, with the unexposed control sample on the right). The one inch edge as shown on the exposed sample was removed prior to testing.

The sizes of the samples were calculated in order to obtain a minimum of three specimens each for flexural strength and modulus, plus inter-laminar shear strength (according to the ASTM Standard D 790 and ASTM D 2344, respectively) at each exposure interval. The test specimens were cut from the exposed block one inch away from the edges, so as not to have the edge effect on the results (See Figure 1).

Exposed samples were mechanically tested at the following intervals (in hours): 500h, 1,000h, 2,000h, 4,000h, 6,000h, 8,000, 10,000h, 12,000h and 14,000h and a visual observation report was prepared by Q-Lab. The exposed sample at the end of the test is shown on the left in Figure 1.

Based on 14,010 hours of accelerated QUV and 2.5 years of natural sunlight exposure testing, it was determined that RStandard poles have an expected service life of 80 years with an approximate 30% strength decrease at the end of the service life. Table 1, below, lists the predicted flexural strength retention at different geographical areas after different service periods based on the life prediction model.^[5] In all cases, RS internal safety factors have been applied to RS pole performance specifications that exceed 130% so that even after 80 years of service, pole strength will remain at the initial published values and pole performance will continue to satisfy application requirements.

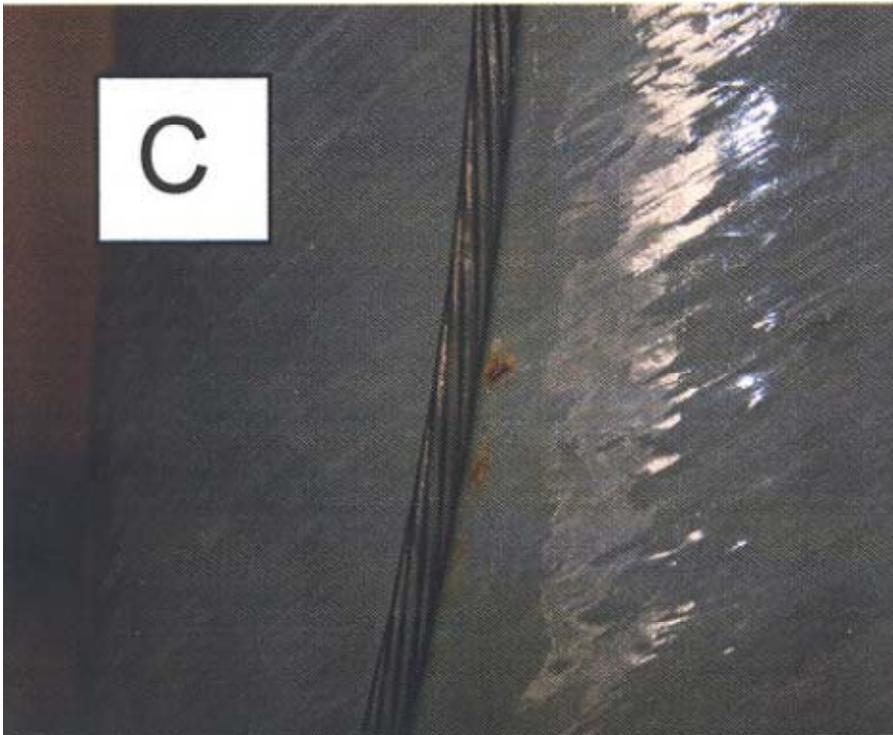
Figure 2: Surface impact of 27.3 kA, 3 cycles fault current with #4 AWG copper conductor at 1,344° F [729° C].

The average lightning strike results in a current flow of 25,000 amps, with only 3% of the strikes being above 100,000 amps. [8] To determine the impact on the pole wall due to the heating of ground wires during a lightning strike, 60 Hz fault current tests were conducted on RS pole sections. The tests showed that with 27.3 kA fault current for three cycles, only small areas of discoloration were observed on the pole surface (See Figure 2), although the copper conductor heated to over 1,292° F [700° C] and became discolored and oxidized. Based on these tests, RS expects that lightning strikes are unlikely to affect the performance of RS poles.

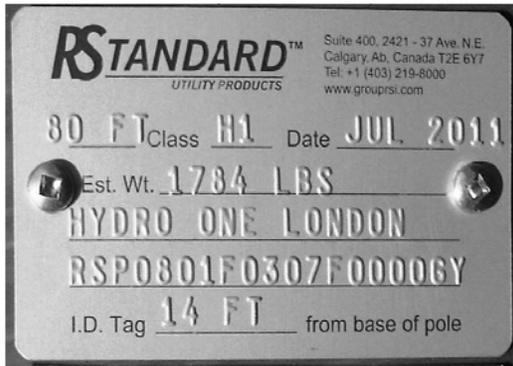
Figure 3: Pole ID tag example

- Check the pole for the RS pole ID tag confirming the specific pole information. The pole ID tag is typically located about 4-6 ft. [1.2-1.8m] above the ground line. See Figure 3, below, for an example of the pole ID tag.

- Inspect the pole ID tag elevation relative to the ground line to ensure that the pole is not settling into the ground, therefore reducing the conductor clearance. From the pole ID tag example in Figure 3 above, an 80 ft. [24.4m] pole is typically embedded 10% of the pole length plus 2 ft. [0.6m] in the ground. This results in an 80 ft. [24.4m] pole being embedded 10 ft. [3m] in the ground resulting in a distance of 4 ft. [1.2m] from the pole ID tag to the ground line. If this distance is less than 4 ft. [1.2m], it indicates that the pole is settling into the ground and may require further action. If a pole ID tag is not present, contact RS Technologies for a replacement pole tag.
- Confirm that the black pole top cap is present, unbroken and attached with four (4) self tapping screws (See Figure 4).

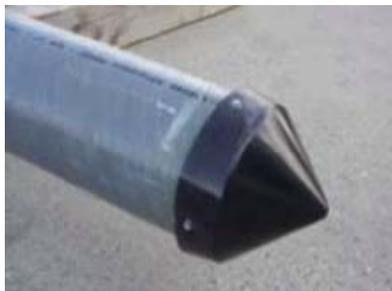
Figure 4: Black pole top cap installed with four (4) self tapping screws.

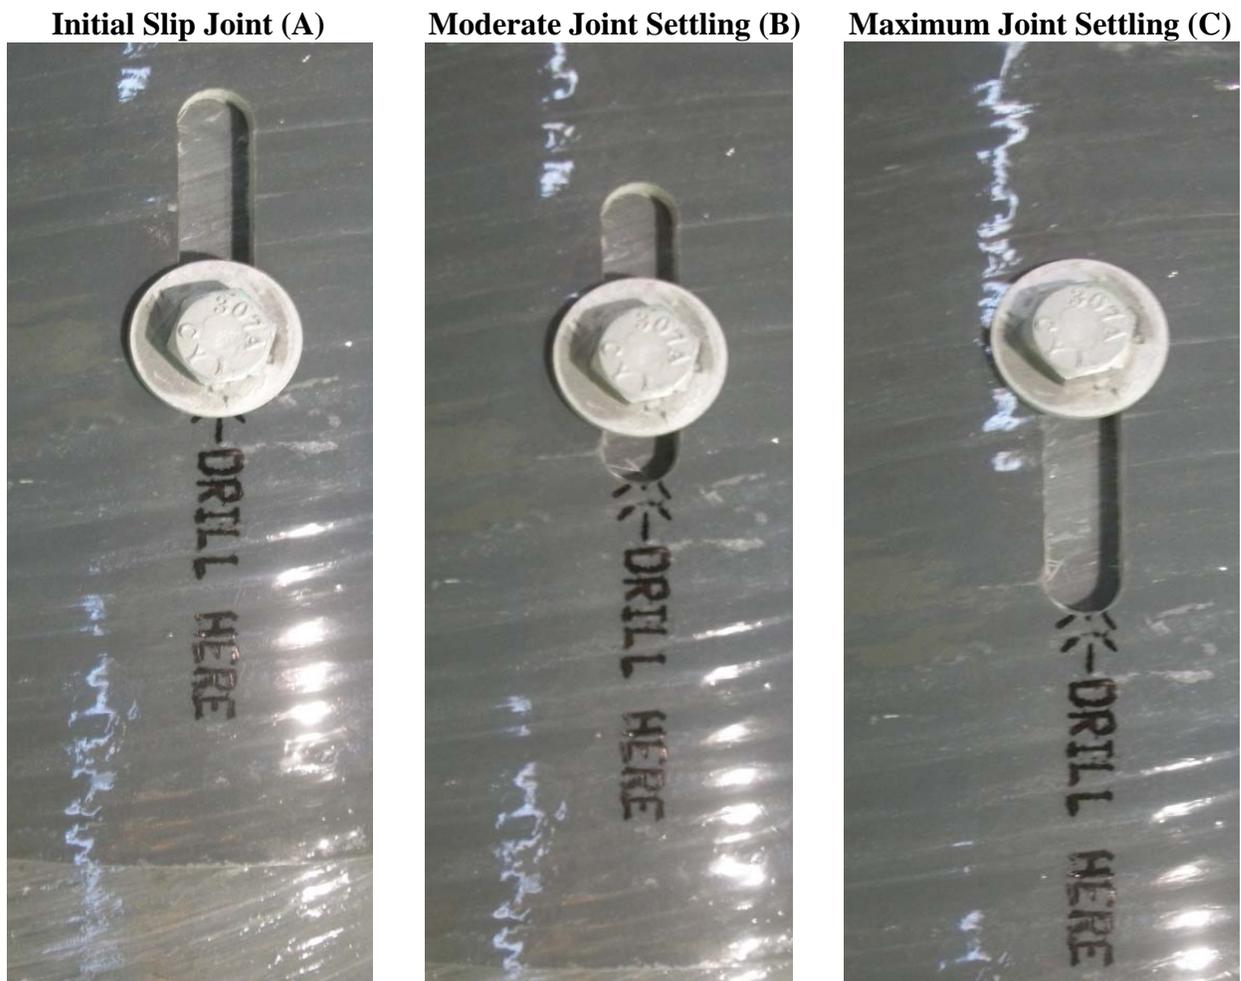
Figure 4: Blind nut bolt head positions after initial installation (A), moderate slip joint settling (B) and maximum slip joint settling (C).

- Confirm that each slip joint is secured with two (2) blind nut assemblies, located 180° apart from each other at the same elevation. At the time of installation, the bolt heads of the blind nuts at the slip joints would be located at the base end of the slot. If the slip joint has settled over time, which the design of the RS pole allows for, the position of the blind nut bolt head relative to the position of the slot will have changed. See Figure 4, below, which shows how the blind nut should appear in relation to the slot at the time of installation and with varying amounts of joint settling.

RS pole slip joints may settle over time on applications with high vertical loads or incorrect initial slip joint assembly. If joint settling occurs, the blind nut bolt head position will change relative to the slot with a portion of the slot becoming visible underneath the bolt head. If upon inspection no portion of the slot is visible above the bolt head, as shown in Figure 4 (C) above, contact RS Technologies as this indicates that the slip joint has settled the maximum distance and further settling could result in laminate damage.

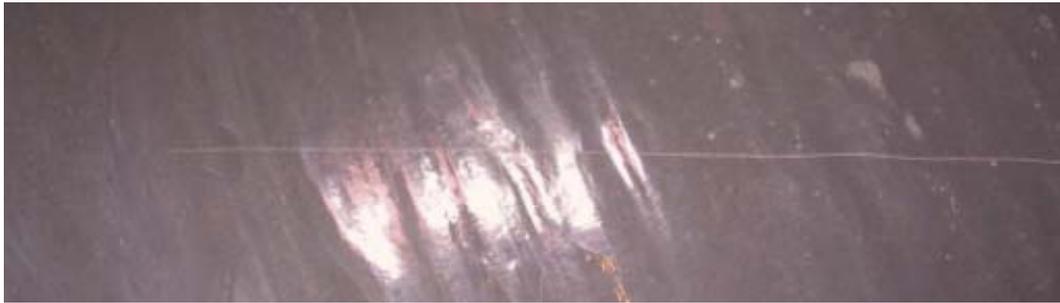
Figure 5: Light superficial damage (scratch), no maintenance required.

Poles should be inspected for laminate damage, and assessed based on the various photos shown below. For detailed evaluation and repair instructions, please refer to RS work instruction WI-7015 - Inspection and Repair of Damage to RS Poles (Rev A). [10] This work instruction categorizes the following conditions that may or may not require maintenance and/or module replacement:

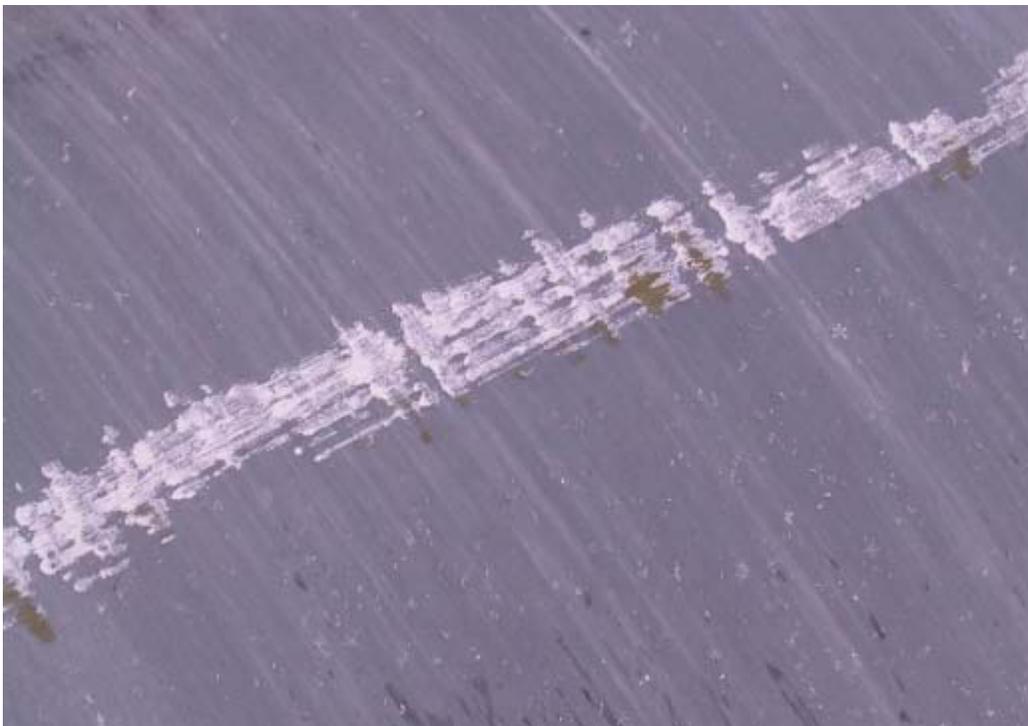
Figure 6: Superficial damage, maintenance may be required.

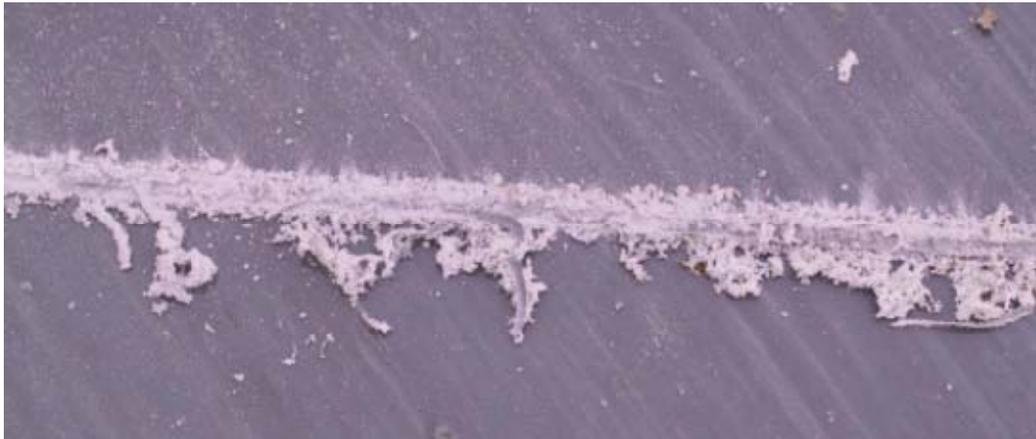
Figure 7: Surface gouge damage, maintenance required.

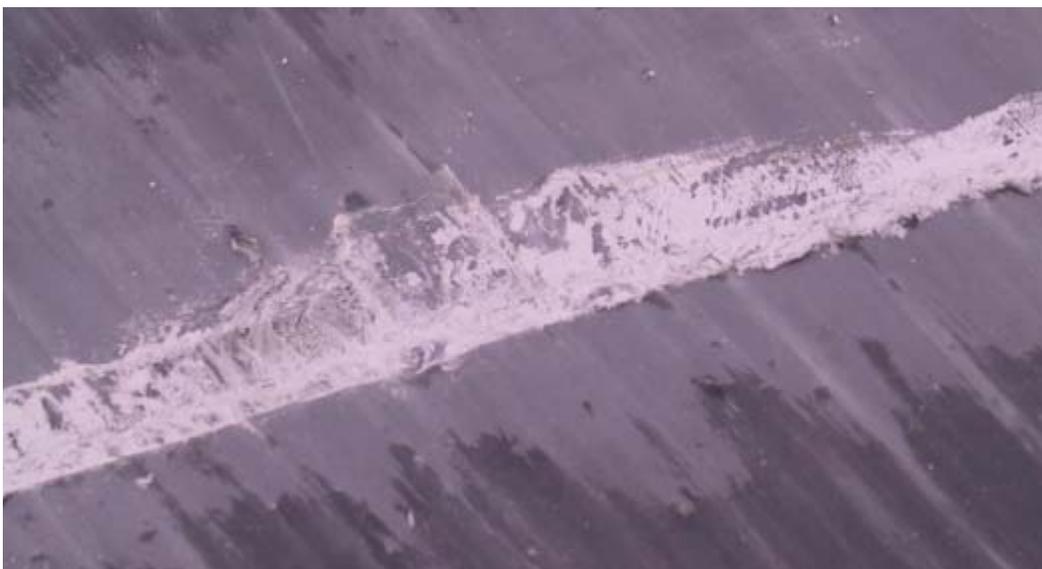
Figure 8: Surface gouge damage, maintenance required.

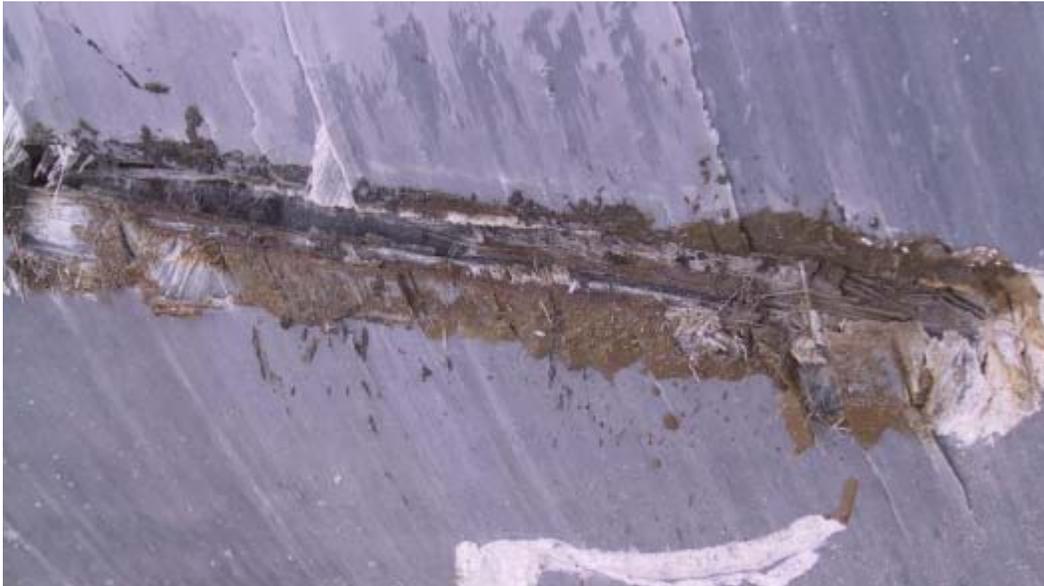
Figure 9: Structural damage, module replacement may be required.

Note, if module replacement is required, the RS pole will need to be removed from the ground and one or more slip joints will need to be disassembled. Refer to RS work instructions WI-7013 - Pole Removal from a Soil Foundation (Rev B) and WI-7014 - Horizontal Disassembly using Boom Truck (Rev A). [11 and 12]

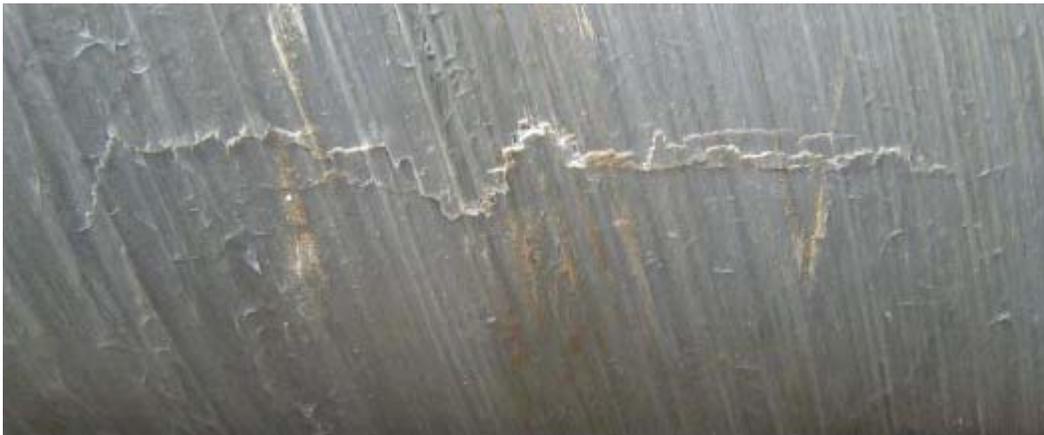
Figure 10: Structural damage, module replacement required.

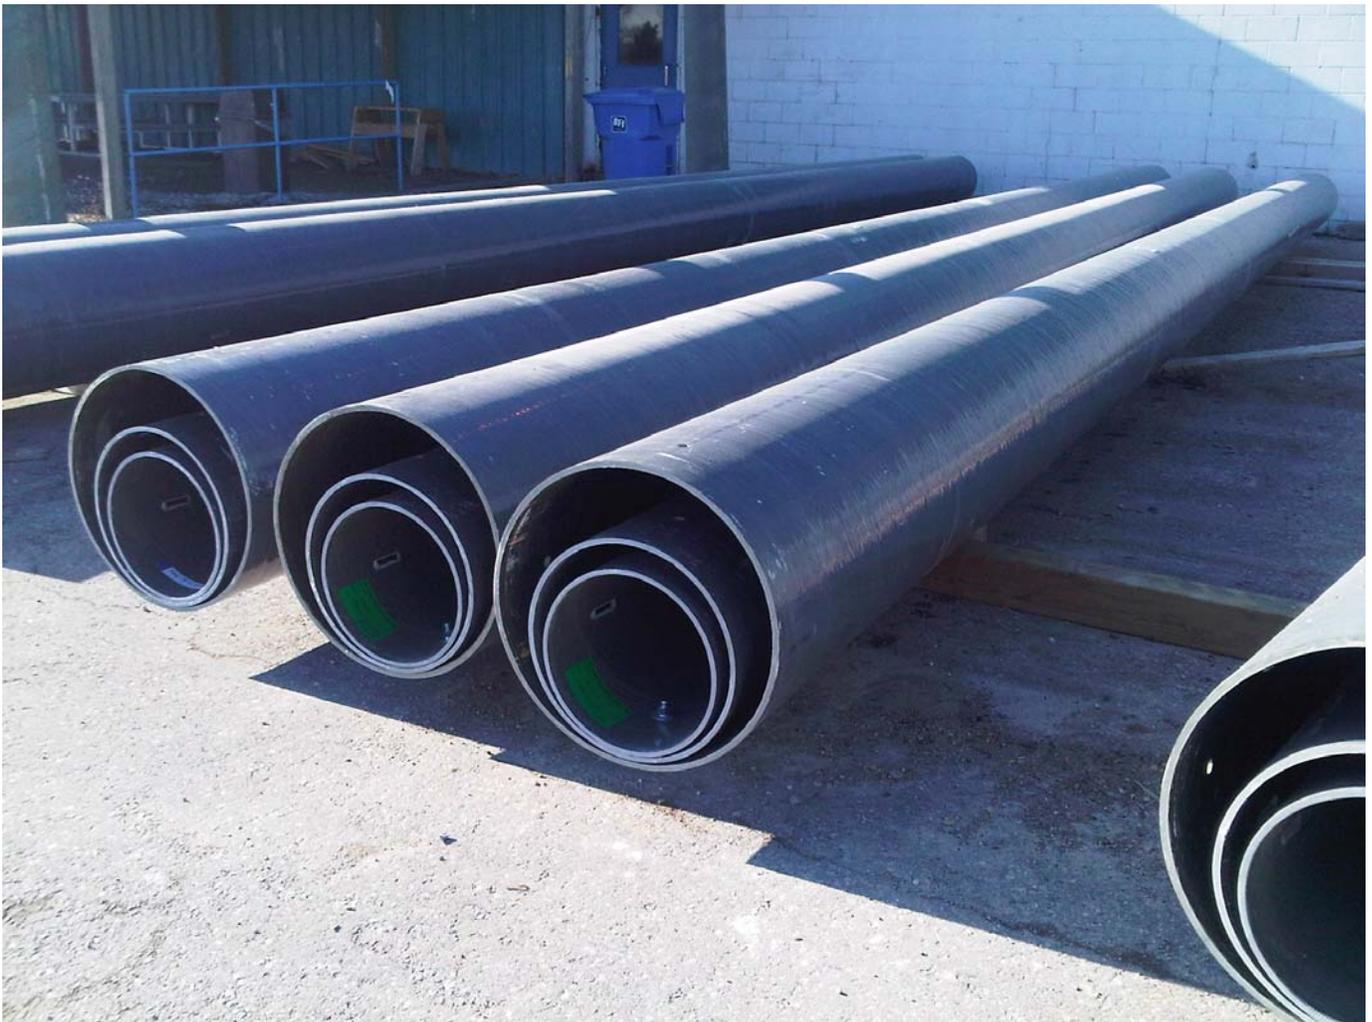
Figure 11: Nested RS module sets stored on wood dunnage with the shipping bolt oriented towards the ground. Note: The shipping bolt is visible just inside the base of the two center module sets to the right of the green QC tag.

During storage, RS poles do not need to be turned periodically nor is periodic inspection or maintenance required. If nested, RS poles should be stored with the shipping bolt oriented towards the ground to allow the smaller nested modules inside the base module to have base to tip contact with each other along the bottom surface of all modules (See Figure 11).

To reduce the potential for debris to enter the nested module sets, elevate RS poles off the ground using wood blocks or similar dunnage (See Figure 11).
